TIMBER RESTORATION SYSTEMS PTY LTD

Newry Island Bridge Retrofit

Bellingen Shire Council

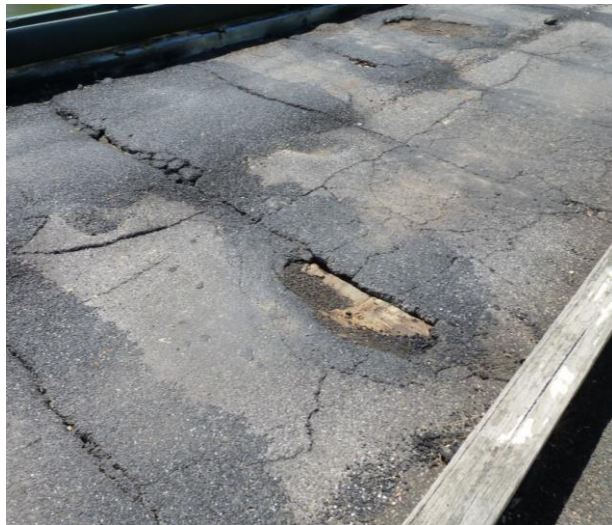
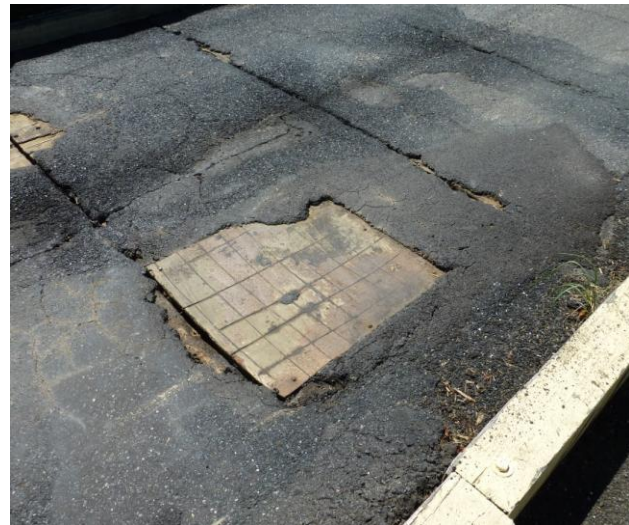
The asphalt running surface is showing signs of wear, and has completely come away from the underlying plywood deck in places.

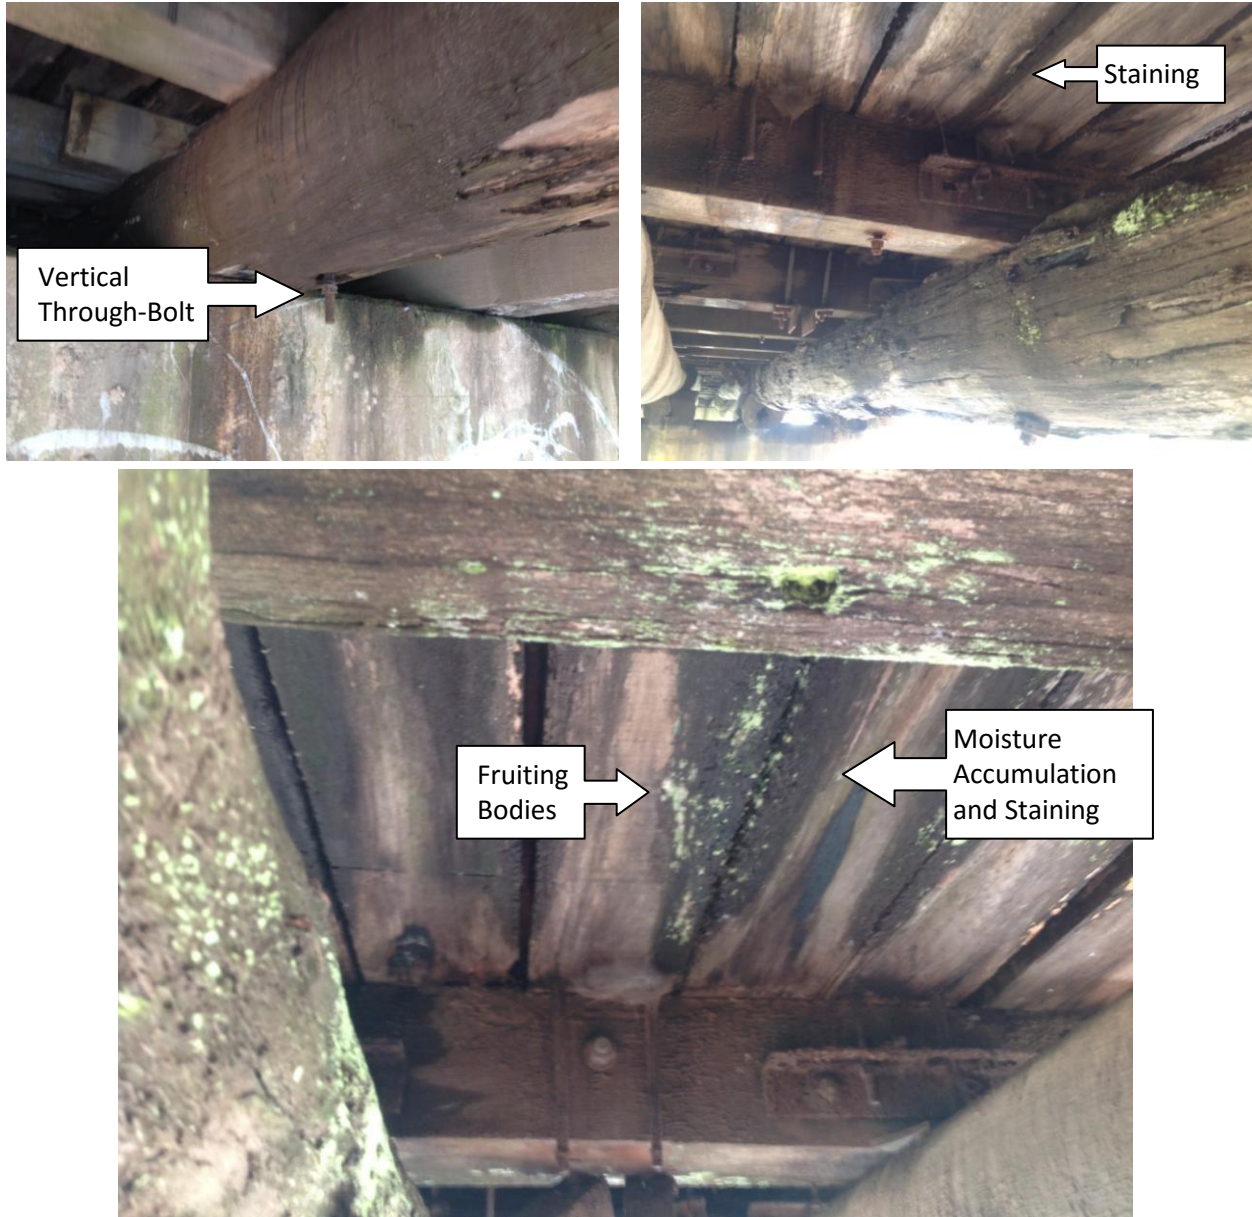
The above photographs show the result of excess moisture leaking down onto the substructure. Notice the vertical through-bolt extending through the bottom of the girder (left photo). Vertical through-bolt type fasteners accelerate timber decay by creating a path for moisture to run down and accumulate inside of the timber element (girder, corbel, etc.). The staining on the underside of the timber deck panels is a sign of moisture coming through the deck and draining onto the sub-structure (right photo). The accumulation of moisture has led to fungus (fruiting bodies) growing on the bottom exterior of deck planks (bottom photo).

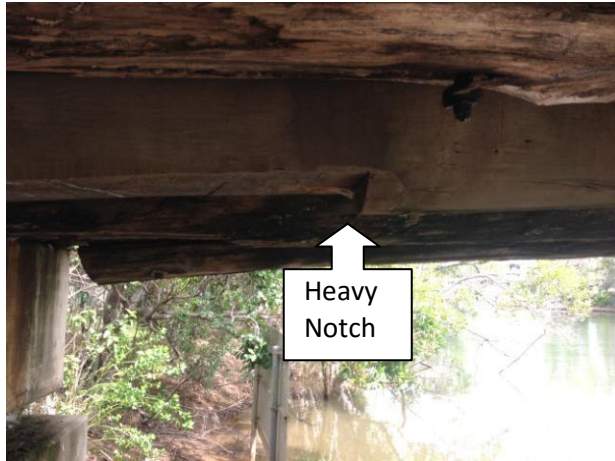
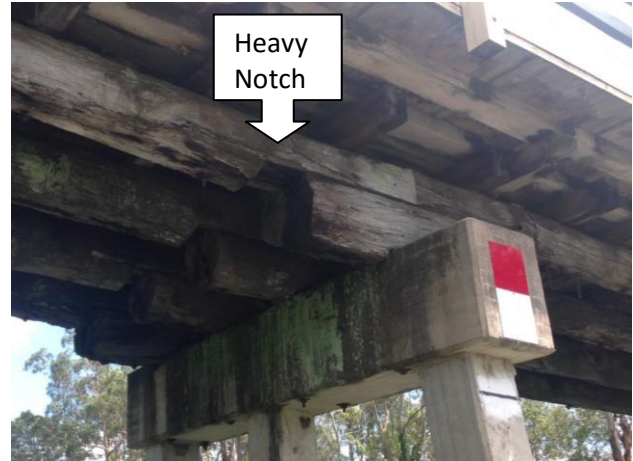
Corbels throughout the structure have been heavily notched, resulting in horizontal cracking and failure of the timber element.

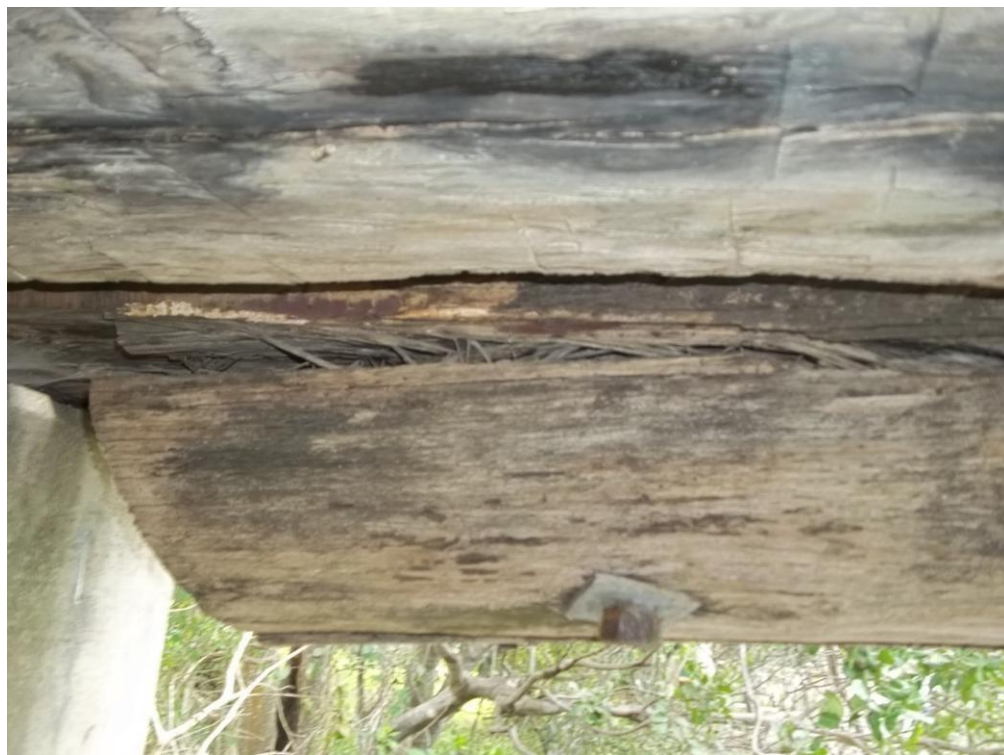
The above photograph show a corbel with a heavy notch, and the resulting horizontal crack and failure. Notice the vertical through-bolt extending through the corbel. This bolt most likely allowed moisture to collect inside the corbel, weakening the timber element.

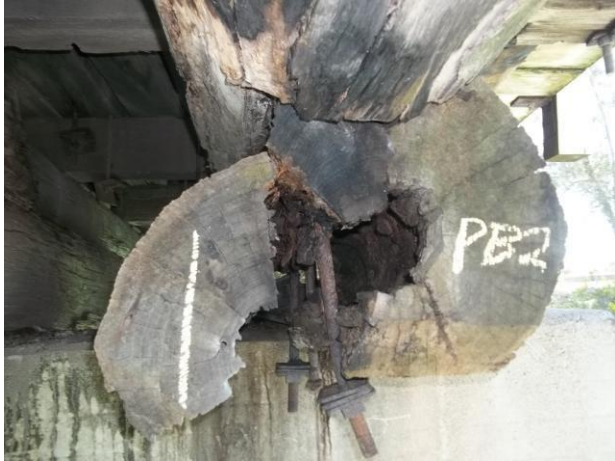
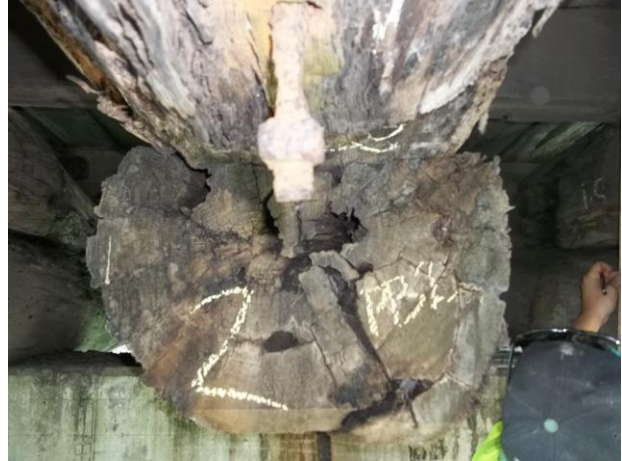
The above photograph illustrates the end result of vertical through-bolt type fasteners. Vertical through-bolts accelerate timber decay by allowing moisture to run down the bolt and accumulate inside of the timber element. Eventually the timber element will fail completely and collapse similar to the above example.

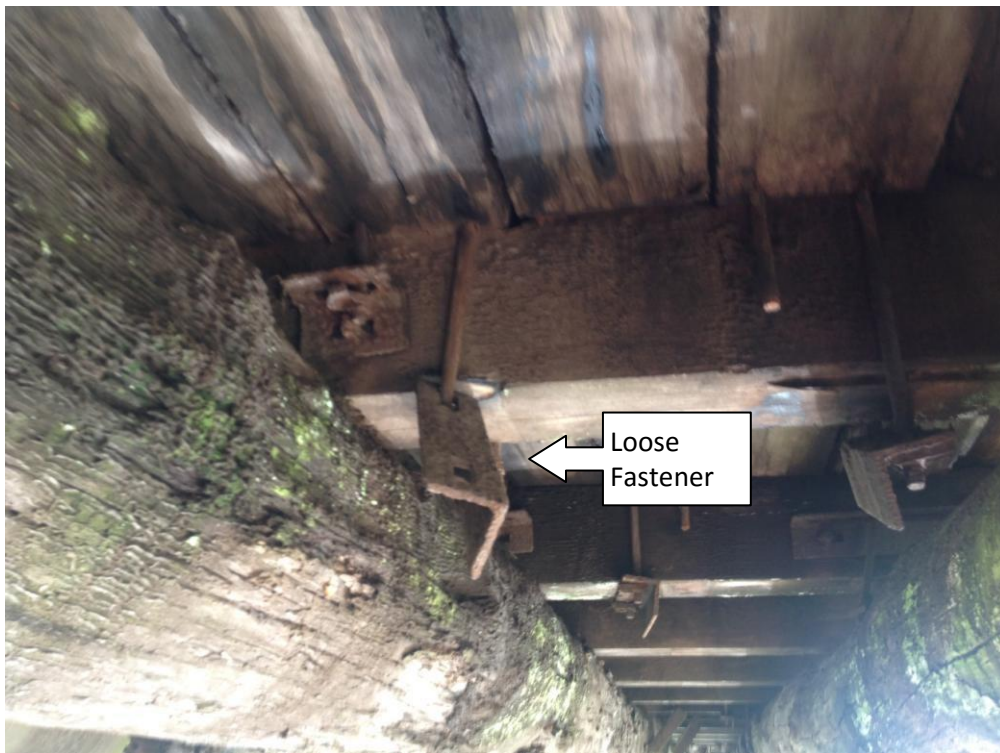
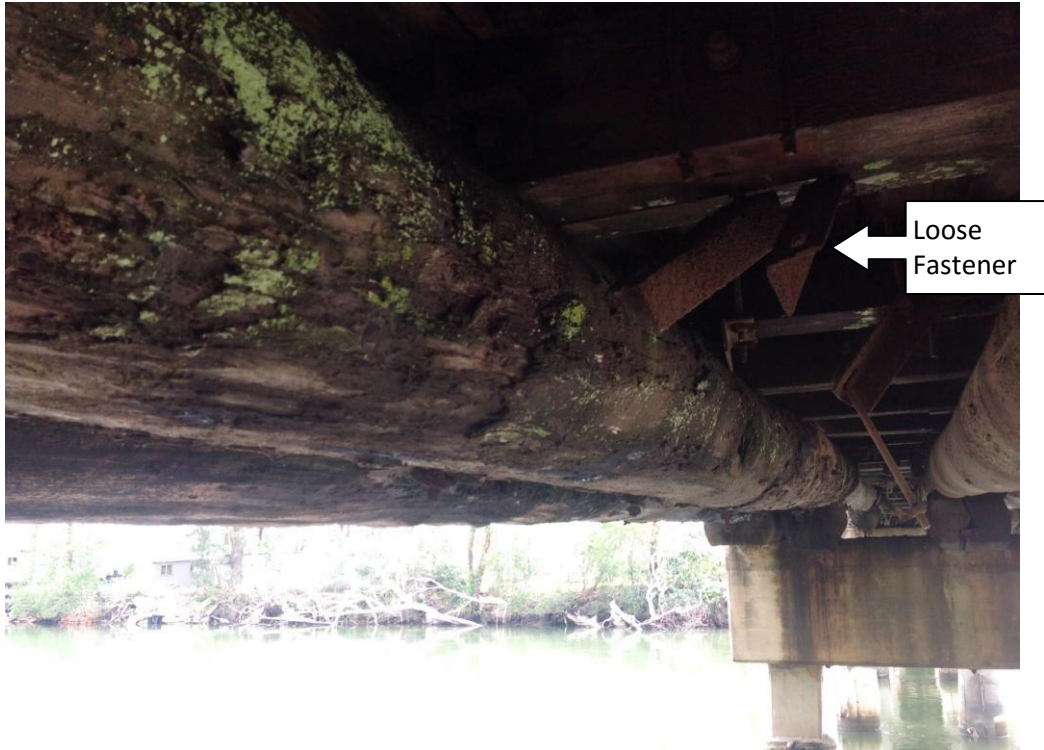
Various fasteners throughout the structure were found to be in poor condition, with some completely detached from the structure. The visual and physical inspection conducted by TRS technicians found multiple areas of concern. The deck panels and railing system were found to be in poor condition and were recommended to be replaced. Girders and corbels were found to be excessively decayed and ready to collapse. Nearly all of the fasteners in the sub-structure are excessively decayed from the salty environment and require replacement. In order to repair the structure and achieve the 44 ton rating required by the council, TRS recommends a complete replacement of the bridge super-structure including deck panels/planks, kerbs, guardrails, girders, and corbels with new Penta treated glulam beams and deck panels.

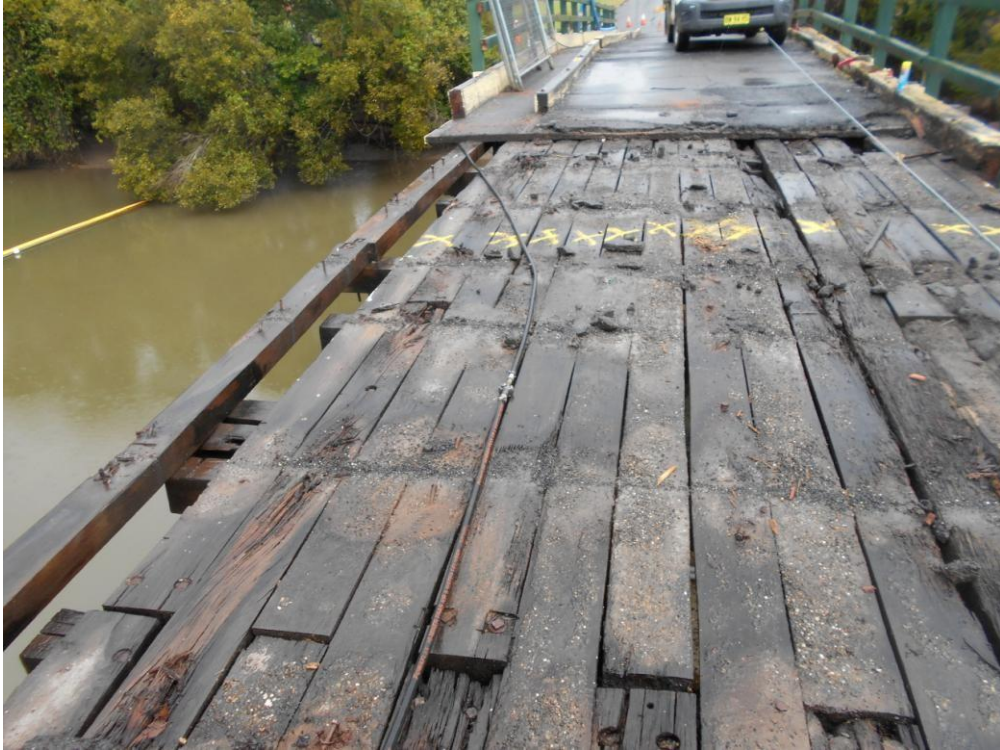
Once the asphalt was removed, the full extent of the deterioration of the deck system was evident.
