# Flowerdale Lagoon: Pedestrian Foot Bridge

*The original Flowerdale lagoon bridge to be replaced as a part of council project.*

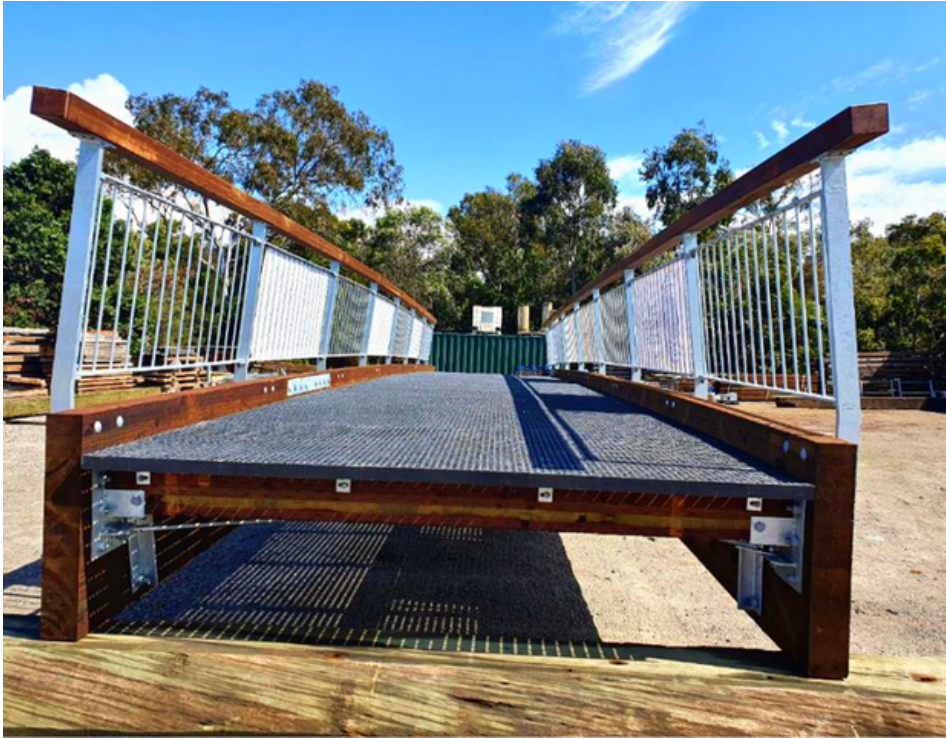
*Treated Engineered Glulam Side Girders with FRP mesh grating.*

The treated engineered glulam side girder superstructure configuration brought together a package of strength, curvature, and natural elegance that blended well in the bushland environment of the Flowerdale precinct. The angled handrail and balustrade design naturally guide cyclists to not ride close to balustrading, preventing their pedals from being caught. A timber top rail of dressed 200×100 hardwood softens the visual presence of galvanized steel posts and balustrading whilst providing a warm natural texture as pedestrians walk along the bridge

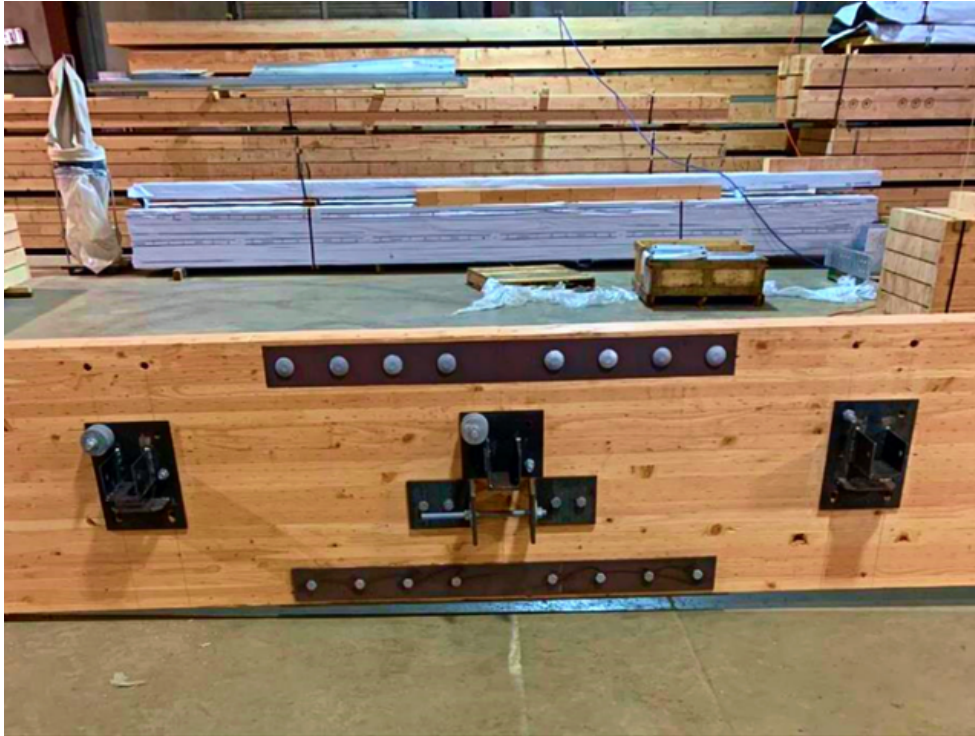
*Connections are pre-assembled in our plant in Jefferson, Oregon.*

Once the WRD design drawings were finalized and approved by Wagga Wagga City Council, the glulam fabrication shop in Jefferson, Oregon began fabricating the components. Once fabricated and quality checked, the bridge was assembled, then disassembled, and sent to the treatment plant.

With Timber Restoration Services having ISO accreditation, the ISO quality audit before treatment is an important step in achieving the quality standards expected by the clients. Pre-fabricating the glulam components with holes drilled before treatment means that the special preservative treatment can coat all

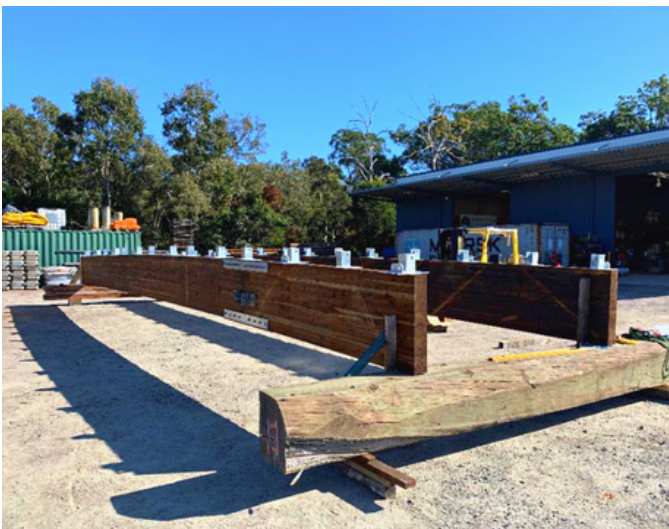
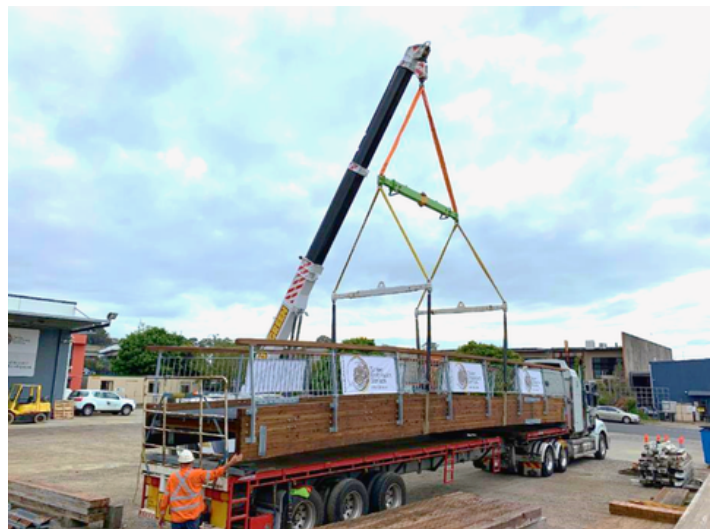
The benefit of this method is the quick assembly and construction time. The treated engineered glulam elements are prefabricated, assembled, and disassembled in the workshop prior to being shipped from the US. Once in TRS' Queensland yard, the timber structure was then assembled including the FRP mesh decking and balustrading for a final quality audit and ready for transport to the site as a complete unit.

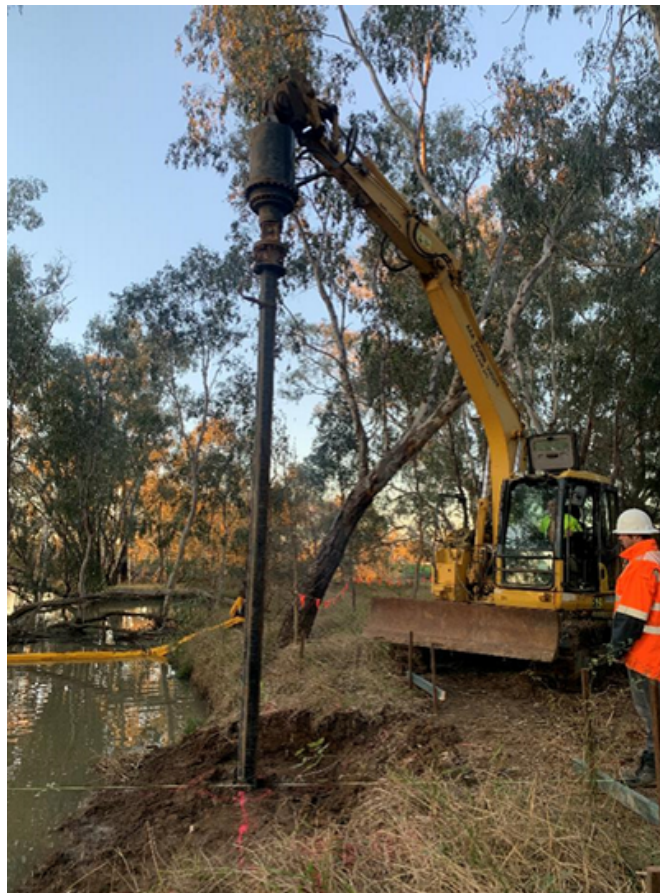
*TRS crews screw piling along banks*

With poor foundation soil quality (silty alluvial clay) and difficult site access for heavy machinery, TRS opted for screw piers as the means to achieve bearing capacity and lateral resistance for the abutments. 2off 178mm dia.x 8.4mm wall thickness screw piers were screwed under each abutment to a depth of 6m. The heads of the screw piers were then integrated into a concrete pile cap and back wall. Since the site had strict environmental caveats, limiting tree lopping and clearing, the 8T screw piling excavator was able to easily manoeuvre in position without disturbing tree overhangs.

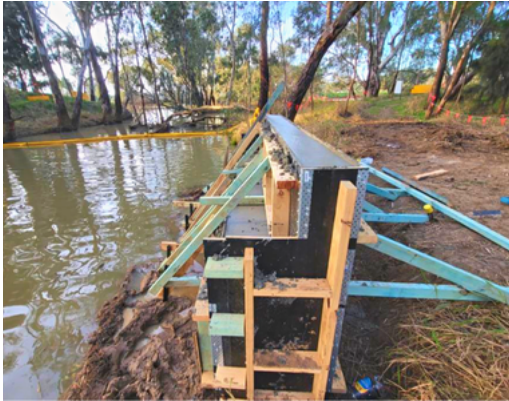
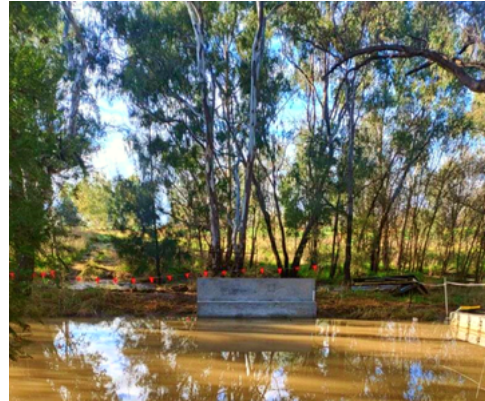
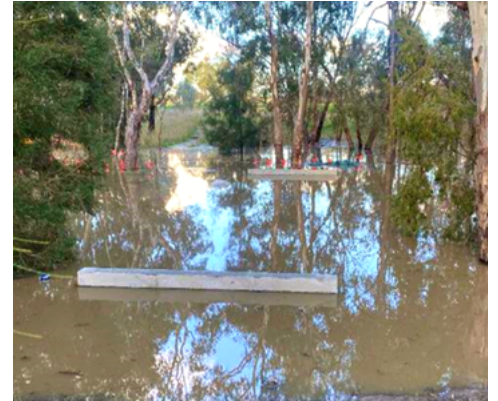
However, a week after the concrete abutments were formed and poured, the site flooded and with ongoing intermittent rain, the bridge installation was delayed. The wet ground conditions from rains and flooding made life difficult in addition to the site's awkward position made the installation a challenging process.

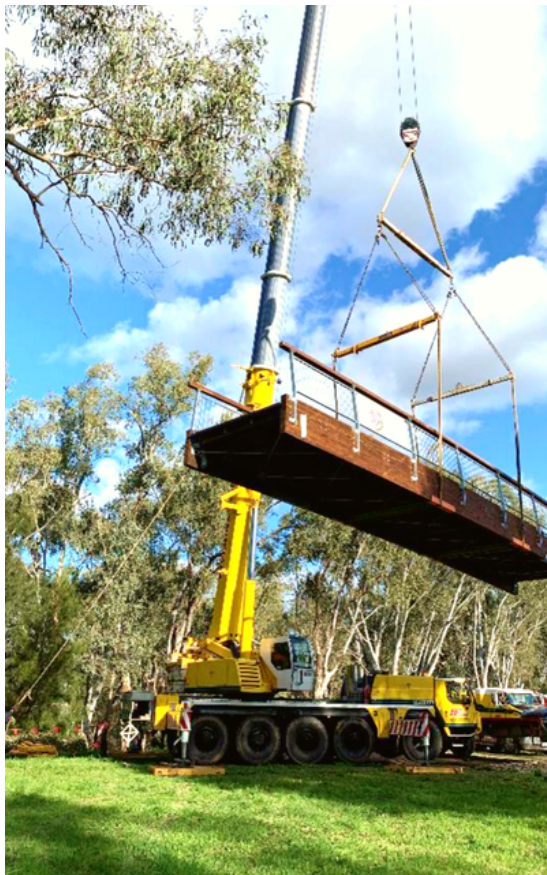
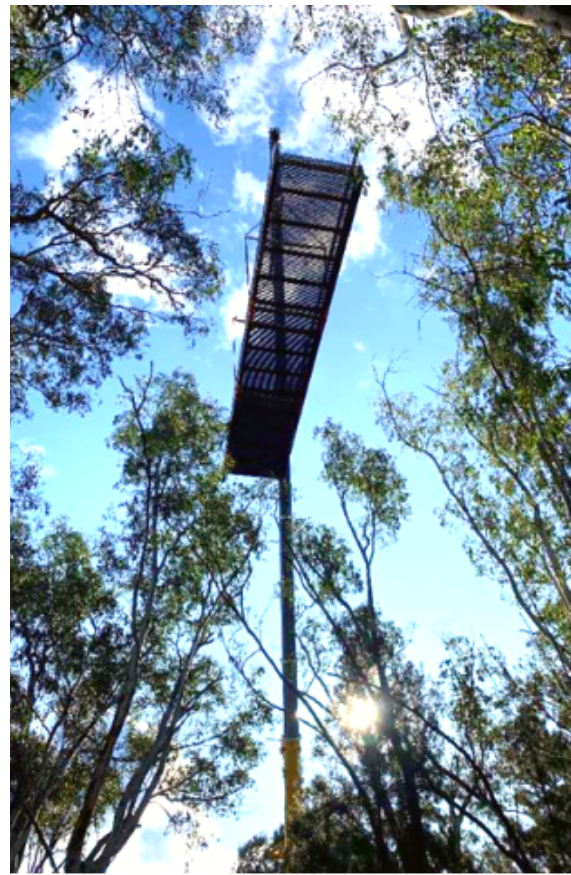
Due to its strict environmental caveat, placing a crane close to the bridge site to lift the bridge in was not possible. A 100 tonne capacity All Terrain mobile crane with a reach of 52m was brought in to lift the 4.8 tonne footbridge directly off the truck, raise it over the tall gum trees that lined the lagoon, before lowering it onto the new concrete abutments

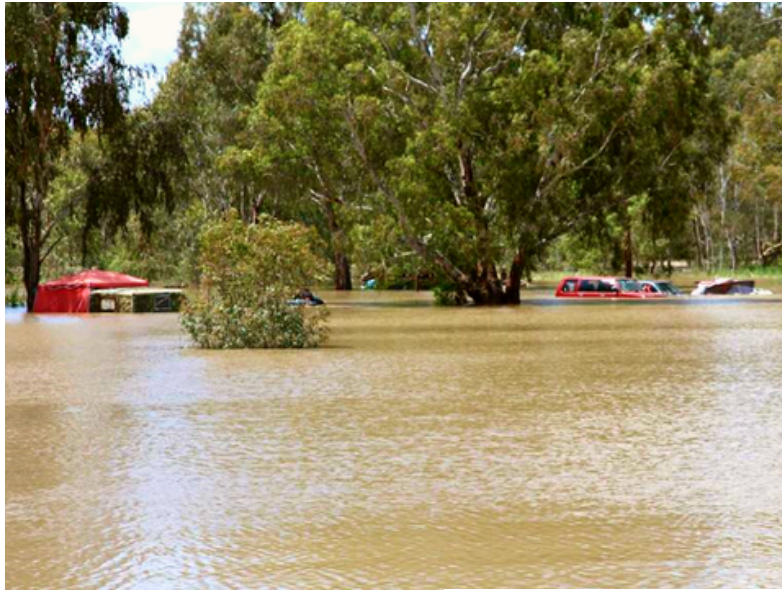
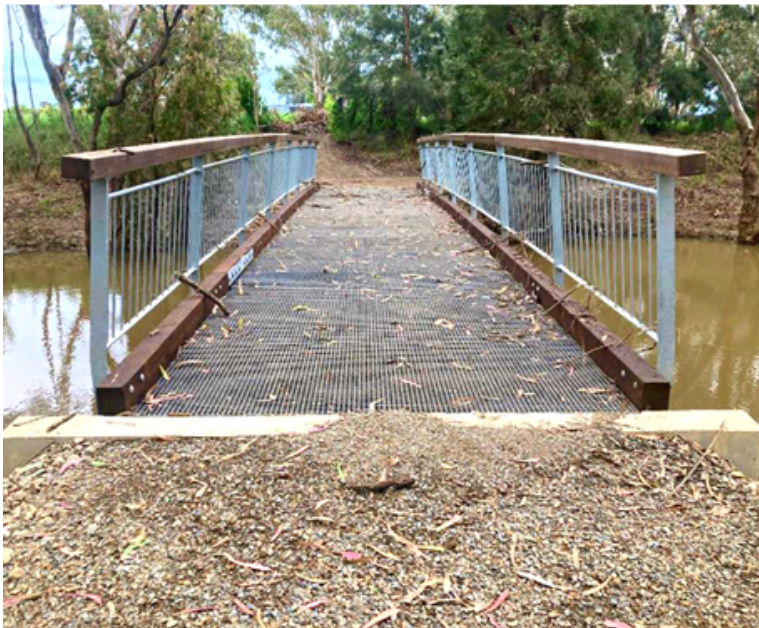
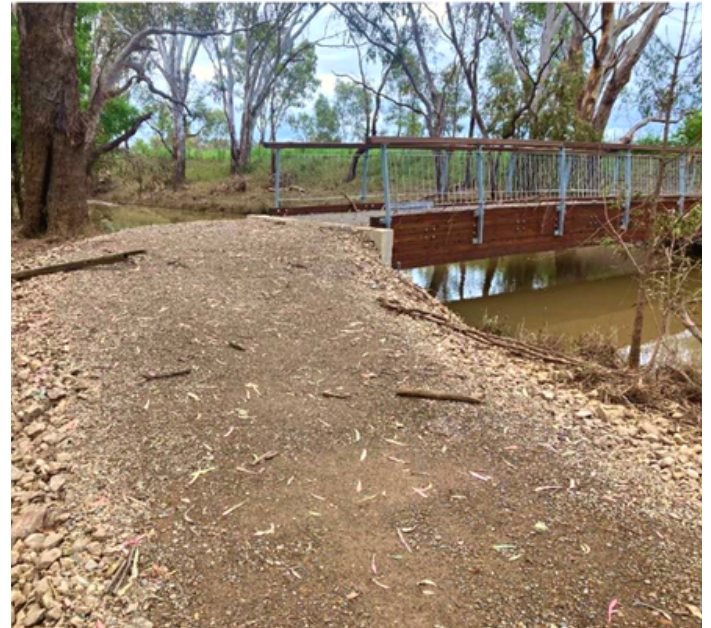
*The Flowerdale Lagoon footbridge, just a few days after flooding in the area subsided.*

A few weeks post-project completion weeks, Flowerdale Lagoon's newest attraction was subjected to the flooding waters of the Murrumbidgee River and passed its first test of endurance with flying colors. The Murrumbidgee River at Wagga Wagga peaked at 9.72 meters, causing major flooding in the city for the first time in a decade. The flood waters rose well above the footbridge cycle rail height which is set at 1.4m above the deck level.
